Inspection Report

Project information	
Customer name	Laser Prototypes
Organization	3D Scanning, Reverse Engineering, Inspection and 3D Printing
Project name	LPE Model
Part number	Model - 123
Drawing number	Model - 123 Rev A
Units	mm

Part information	
Part name	LPE Model
Date	22/08/2023
Time	11:47
Operator name	Sean Norris
Device	HandyScan 700 Elite Silver

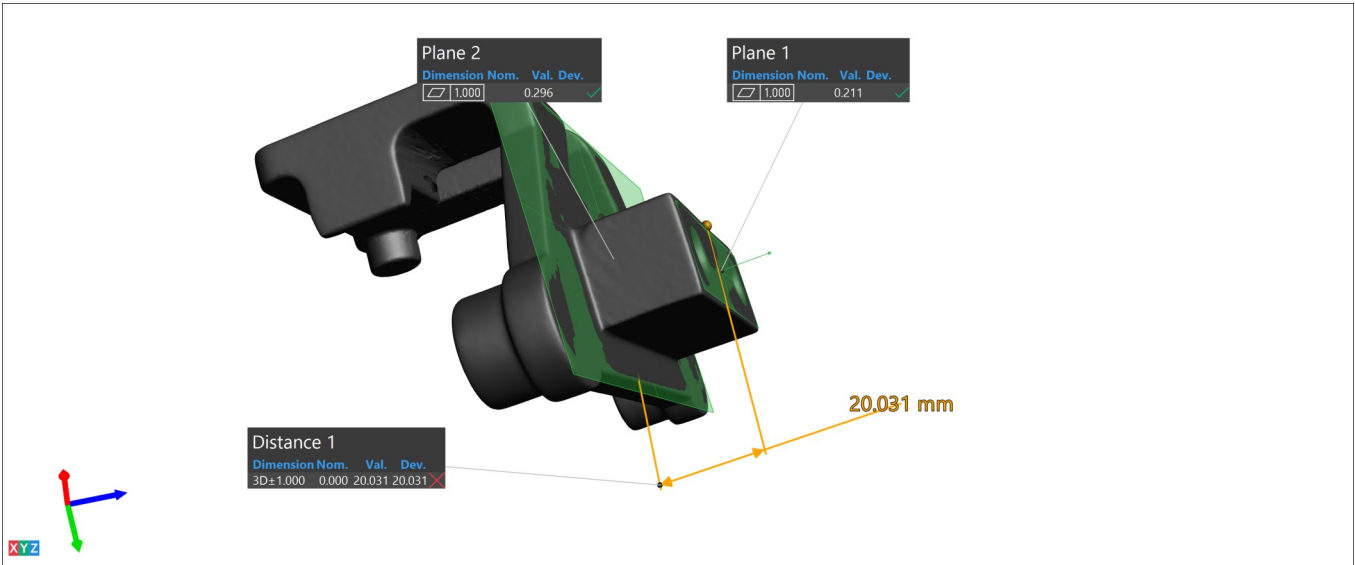
Distance 1

Alignment : Surface best fit 1

Dimensions	Tolerance	Nominal	Measured	Deviations	Tendency	Out of tol.
3D	±1.000	0.000	20.031	20.031		19.031

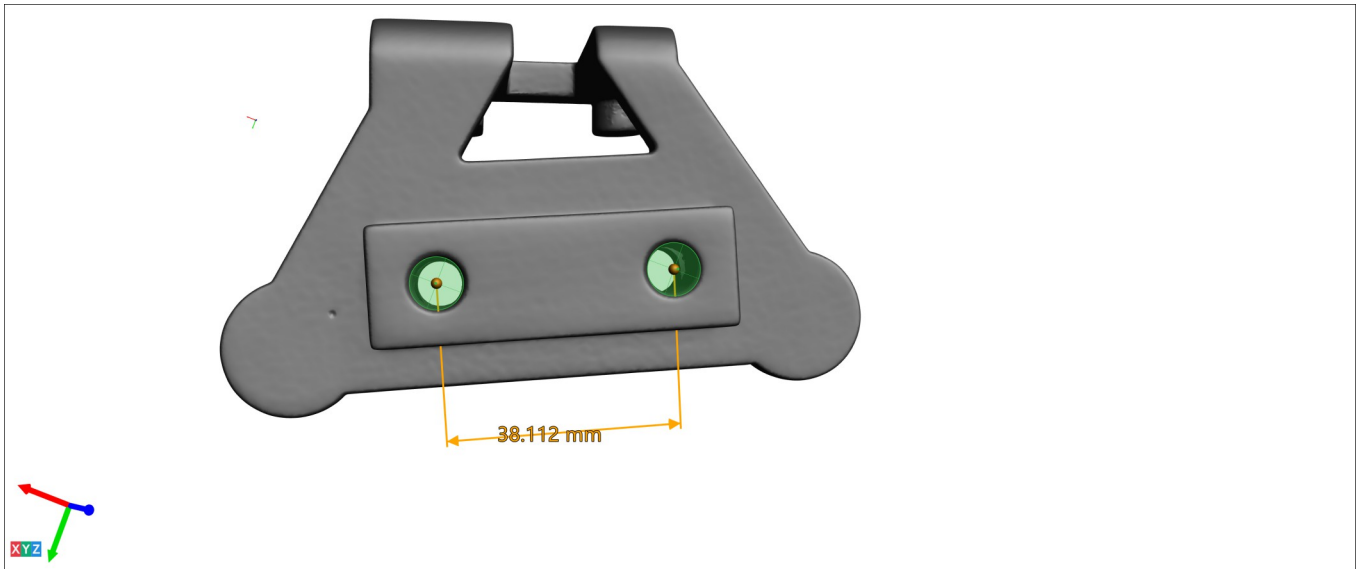
Hole Distance

Distance 2

Alignment : Surface best fit 1

Dimensions	Tolerance	Nominal	Measured	Deviations	Tendency	Out of tol.
3D	±1.000	0.000	38.112	38.112

37.112
